1. REPORT DATE (DD-MM-YYYY) 10-3-01		2. REPORT TYPE Final		3. DATES COVERED (From - To) 3-1-99 to 11-30-00	
4. TITLE AND SUBTITLE Quantitative Characterization of Fretting Damage in Aircraft Turbine Disks				5a. CONTRACT NUMBER	
				5b. GRANT NUMBER F49620-99-1-0148	
				5c. PROGRAM ELEMENT NUMBER	
				5d. PROJECT NUMBER

Quantitative Characterization of Fretting Damage in Aircraft Turbine Disks Final Report

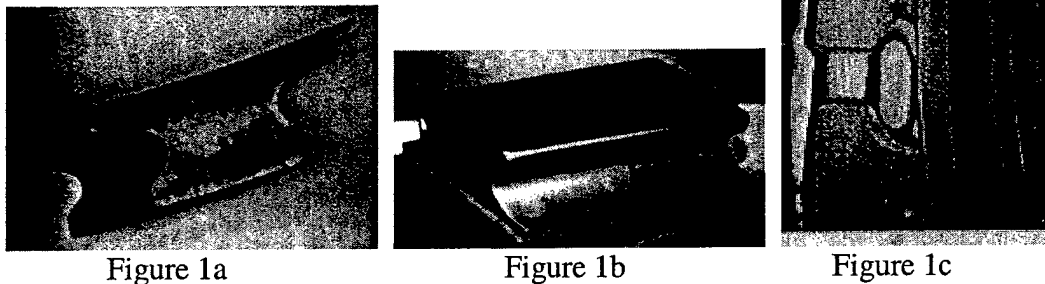
Figure 1 Two views of a section of a turbine disk with fretting damage. Figure 1a is an end view of the disk, Figure 1b is a side view. Figure 1c is an example of a crack initiated from fretting damage.

Figure 2 Optical micrographs of the turbine disk section shown in figure 1. Figure 1a is a normal region without fretting. The ruler shows millimeter spacing. Figure 2b shows the ridge form of fretting. Each ridge is 0.1 mm wide; the fretting surface is 3 mm wide. Figure 2c show the texture form of fretting.

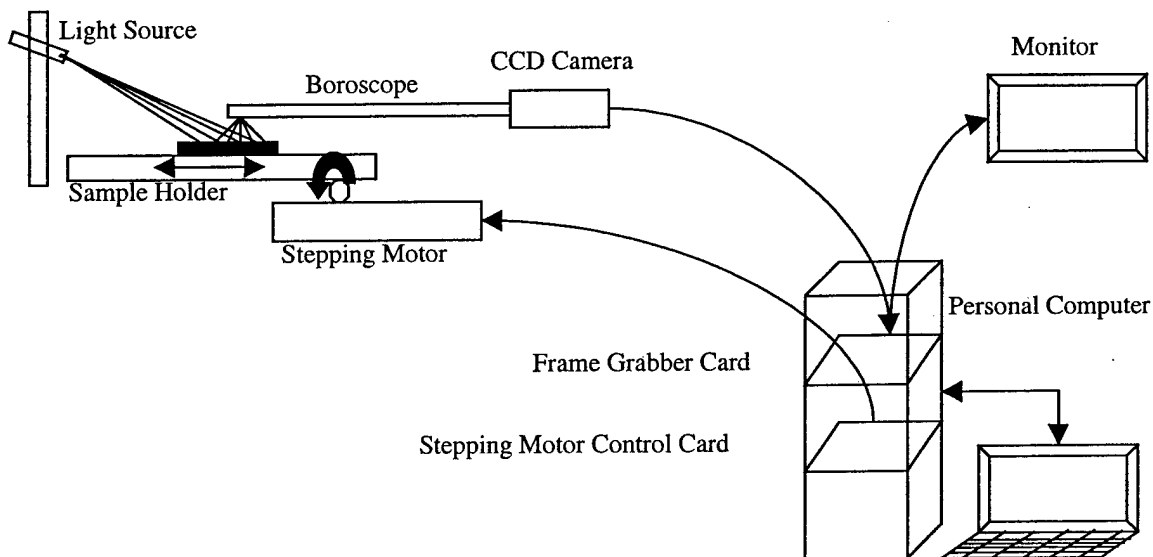
Figure 3 shows a block diagram of the image acquisition system.

The system, shown in figure 3, is made up of a personal computer with a 640x480, 8 bit frame grabber and a stepping motor control card. The CCD camera is connected to a boroscope 450 mm in length and 7 mm diameter. It is used to both illuminate the target and transmit image back to the eyepiece. For our system, the eyepiece is mounted on the CCD camera, which has a pixel size of 20 microns. The stepping motor used is capable of moving the platform with increments of 0.8 microns.

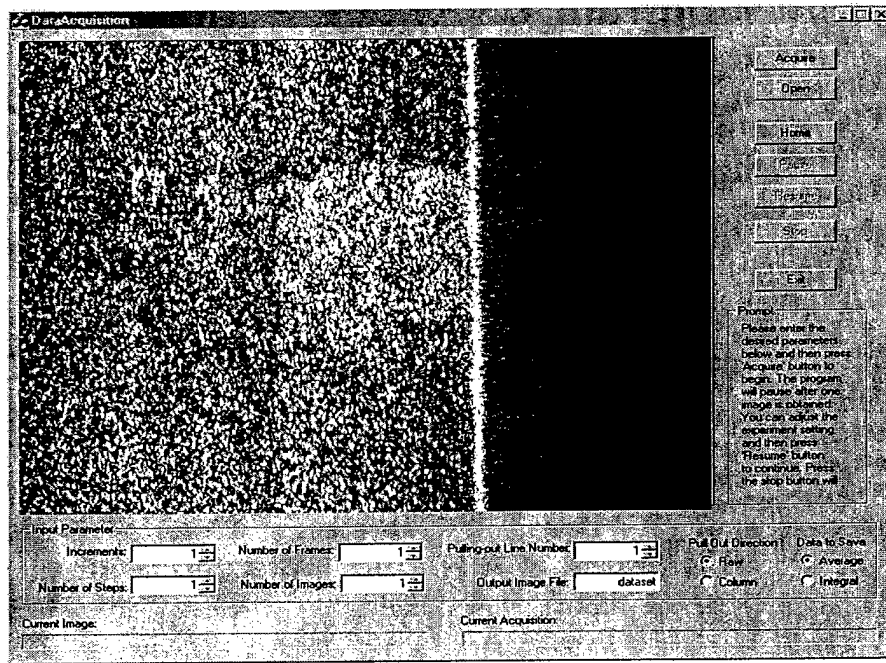
We developed a custom data acquisition program for running the image system. The user interface for that software is shown in Figure 4. The software can store the acquired images in both ASCII and bitmap formats for further analysis. The parameters

set through the software include the number of step increments for each line, number of total lines for an image, number of frames integrated per line, number of overall images to be taken and line number to be used from two dimensional images.

Figure 4. Interface for the data acquisition program controlling the sample scanning and image collection. The image shown is from a laser illumination of a sample.

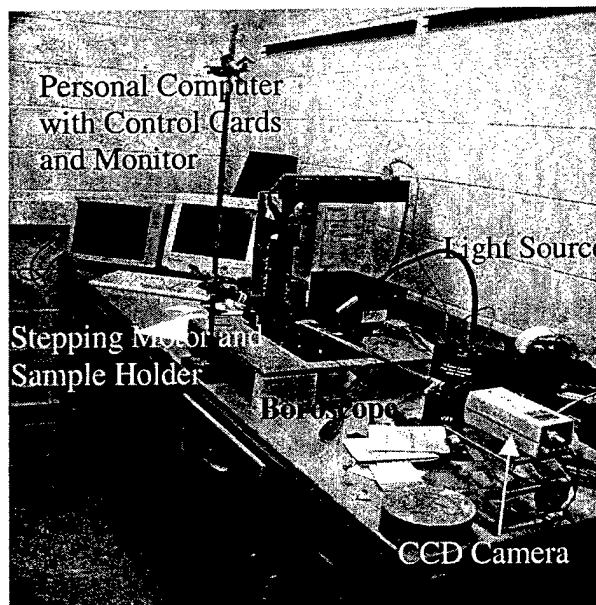
Figure 5. The data acquisition system used to evaluate imaging parameters.

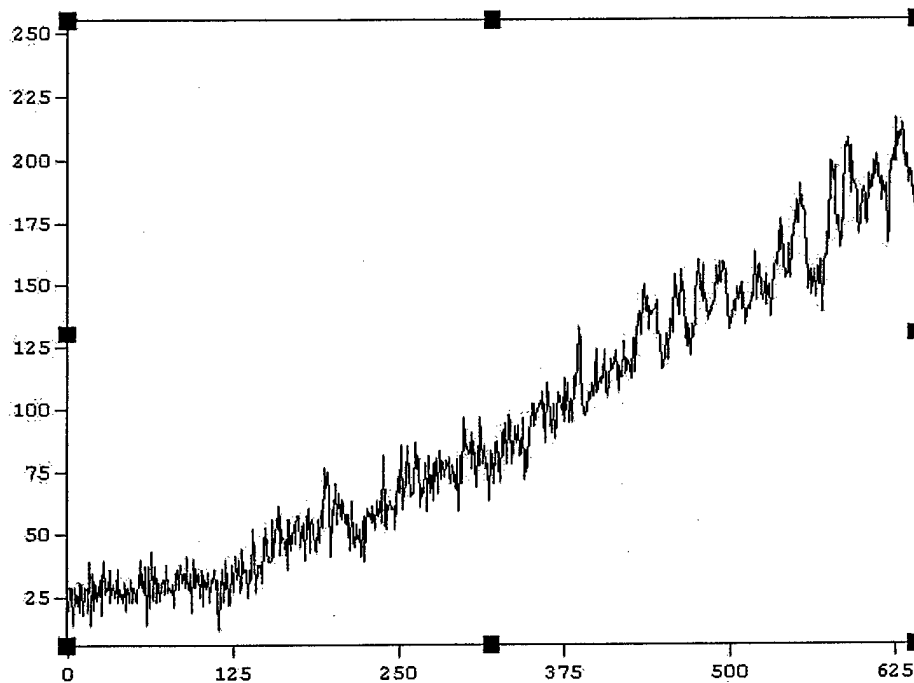
Figure 7. This plot shows the effect of the ambient lighting in the generation of a trend in the intensity of the light. The trend increases to the right; the fluctuation in the signal is the noise. In an ideal system this plot should show a flat plot with the average signal at 25.

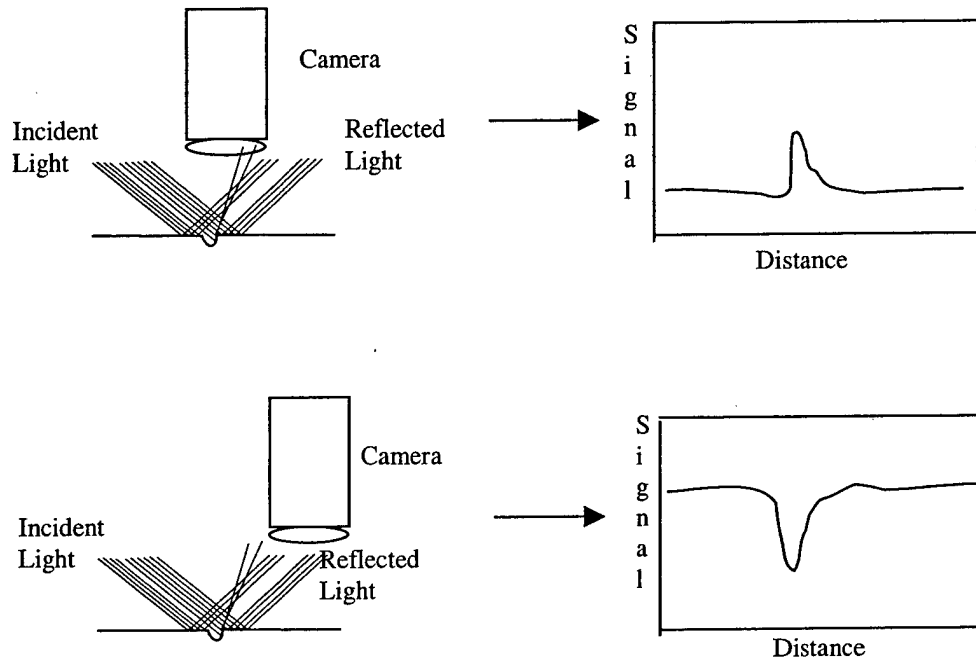
Figure 8. Dark field specular reflection (top) and light field specular reflection (bottom) signal formation cases.

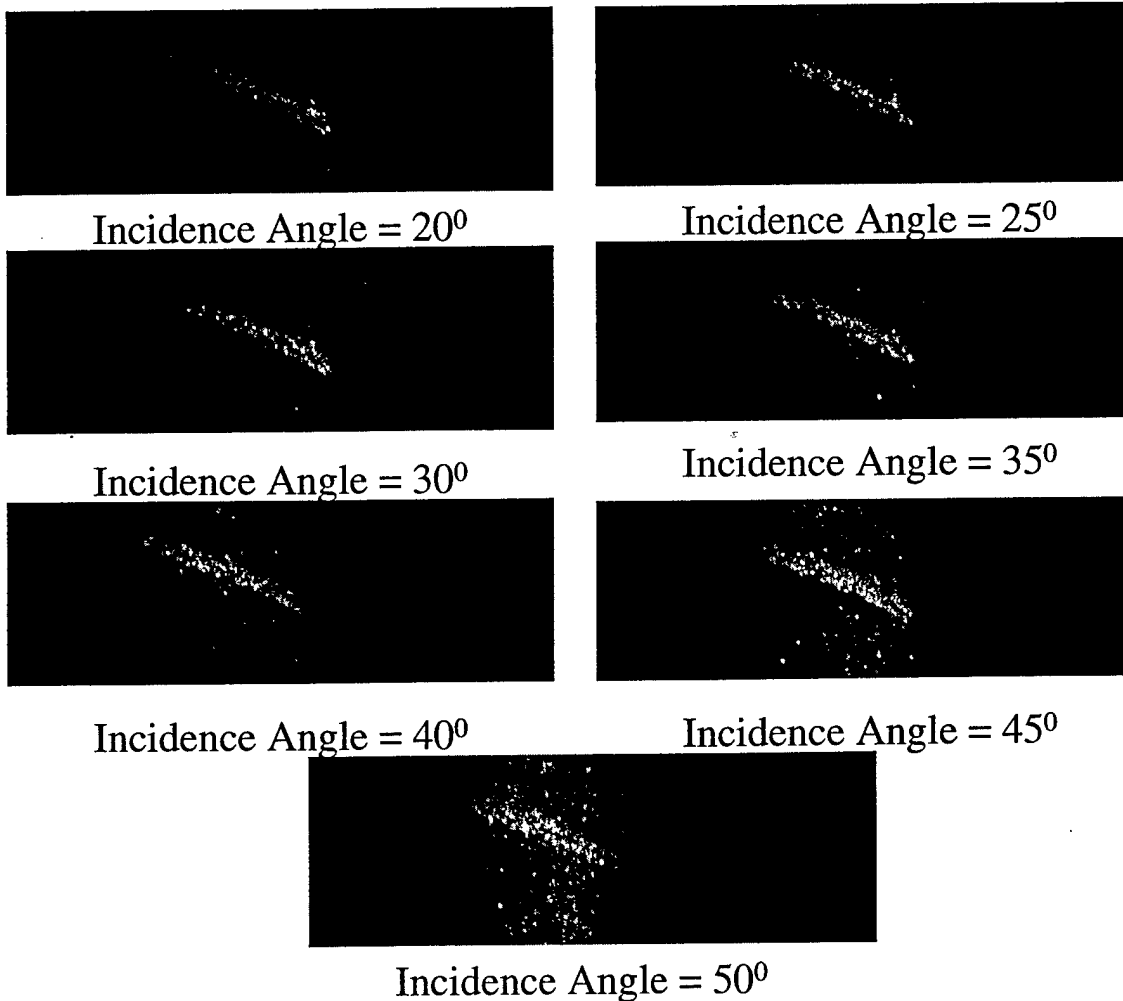
The first set of results is a dark field case. In this case, the laser light incidence angle has been increased from 20 degrees to 50 degrees with 5-degree increments. As the incidence angle increase, the light reflected from the sample background enters into the camera resulting in a reduction in contrast between the surface flaw and the background. The actual dimensions of the surface flaw are 0.24 mm. width and 2.7 mm. length. The boroscope is about 5 mm from the sample surface. The pixel sizes on the images are $15\mu\text{m} \times 12\mu\text{m}$. The images are made up of 640×200 pixels.

Figure 9 A series of dark field images using the laser source and specular reflection. The incident angle was varied over a range of angles from 20 degrees to 50 degrees.

As can be seen in these seven images, the increase in the incidence angle increases signal intensity from the surface flaw. Once the incidence angle passes 40° , the background starts to contribute some to the signal coming from the flaw. In order to show the change in the signal intensity with the incidence angle, we plot the gray scale histogram from images produced light having 20° and 50° incident angles. As it will be seen in Figure 10, the gray scale histogram shifts significantly to the right, a result of the increasing background contribution to the light reaching the camera. In addition to evaluating changes in the shape of the histogram of the images, we also examined the signal intensity by using a threshold where pixel values were converted into a binary scale by applying a threshold value. When the value is below a set threshold, that value was changed to 0, it was changed to 1 if it was above the threshold. Following this, we employed a filter where the small windows of the image were converted to either 1 or 0 if the density of the window was below or above a set density level. By counting the number of pixels in the threshold image with a value of zero we obtain a measure of the flaw area. We plot the flaw area as a function of the incidence angle to show that incidence angle can provide information regarding the flaw area. Figure 11 displays variation of the flaw area as a function of the incidence angle.

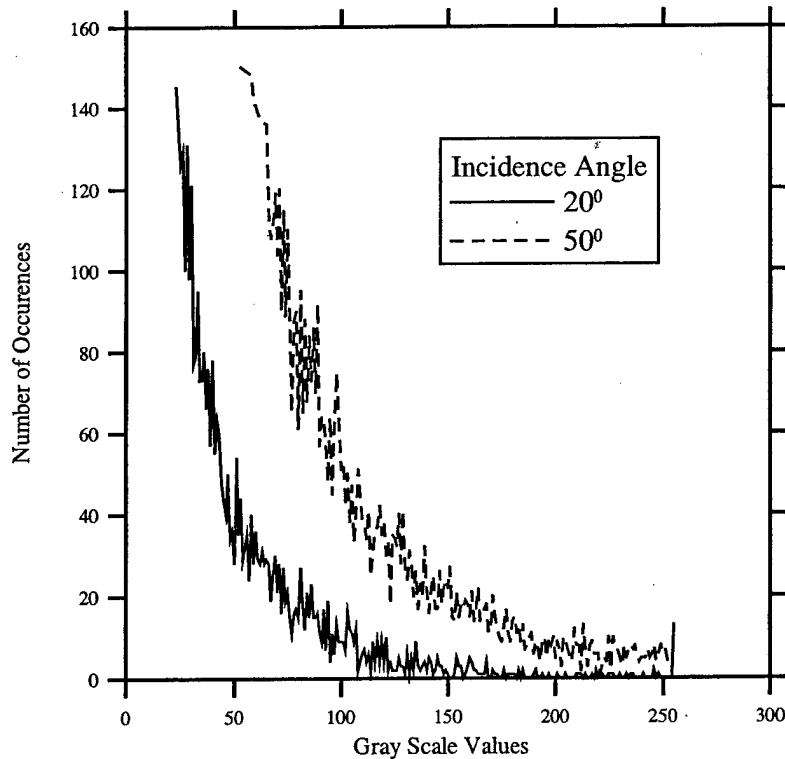
Figure 10. Gray scale values histogram for two incidence angle cases

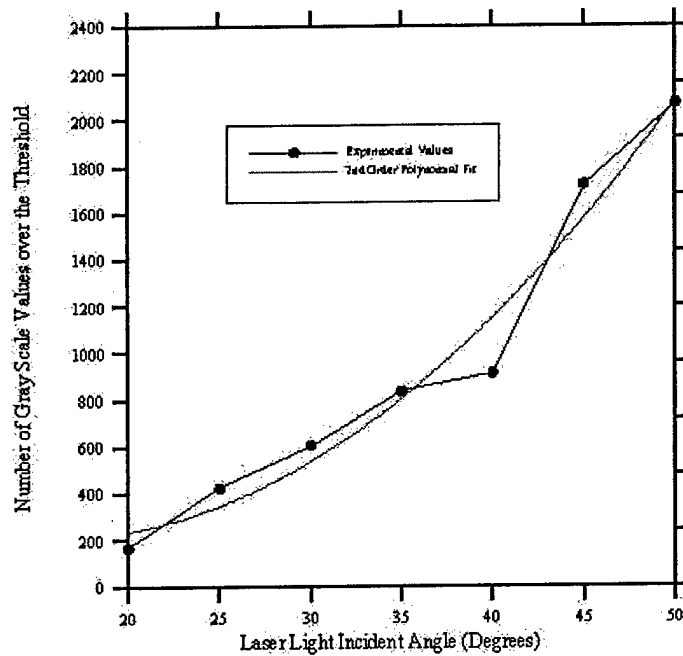
Figure 11. The increasing signal as measured from the thresholded image as a function of angle is shown.

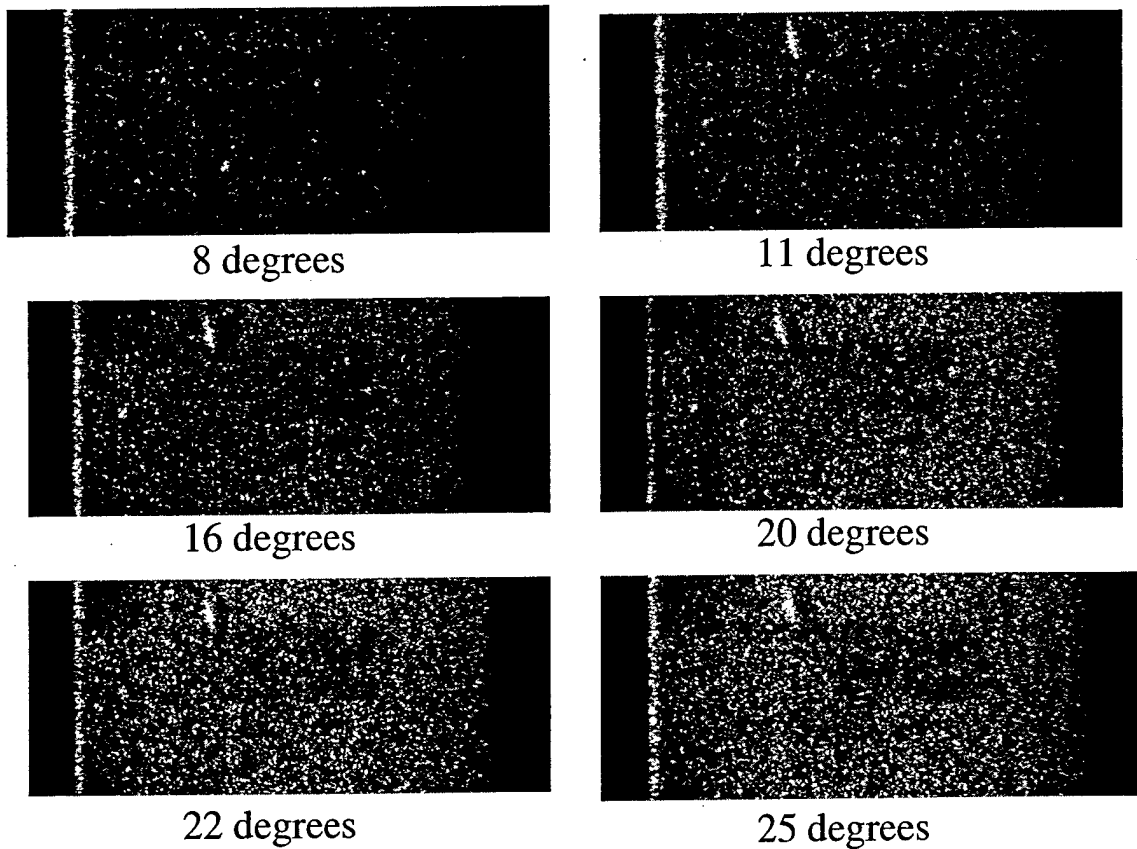
The second set of images is an example of light field specular reflection technique. In this case, the flaw is not a scratch but an area flaw that was formed through mechanical means. Its depth varies between 1-7 μ m. An optical microscope image of this flaw with 50x magnification is given in Figure 8. For this case, we used incidence angles from 8 $^{\circ}$ to 25 $^{\circ}$. These raw images are given for 8,11,16,20,22 and 25 $^{\circ}$ incidence angles.

Figure 13. Images of the sample fretting mark showing the effect of the angle of illumination using specular reflections.

Several sources for this variability were identified, including the effects of the camera responses, the type of illumination, the ambient room illumination and the angle of the incident light. In order to address this issue we developed a data acquisition method that significantly reduced the magnitude of the ambient light and camera artifacts. Several of the important issues from the camera include the imperfect pixel to pixel response. In an ideal camera with a uniform illumination, the result would be a constant valued image. This is not the case. The addition of the variable ambient lighting resulting from the scan position changing along the surface exacerbated this effect. By using a single row of camera pixels and scanning the surface much like a x-ray baggage scanner, we were able to eliminate much of the signal variability. The results of the illumination angle could now be systematically studied. The results illustrated in figures 13 and 14 show the reproducibility of the images and the much more tractable uniform backgrounds.

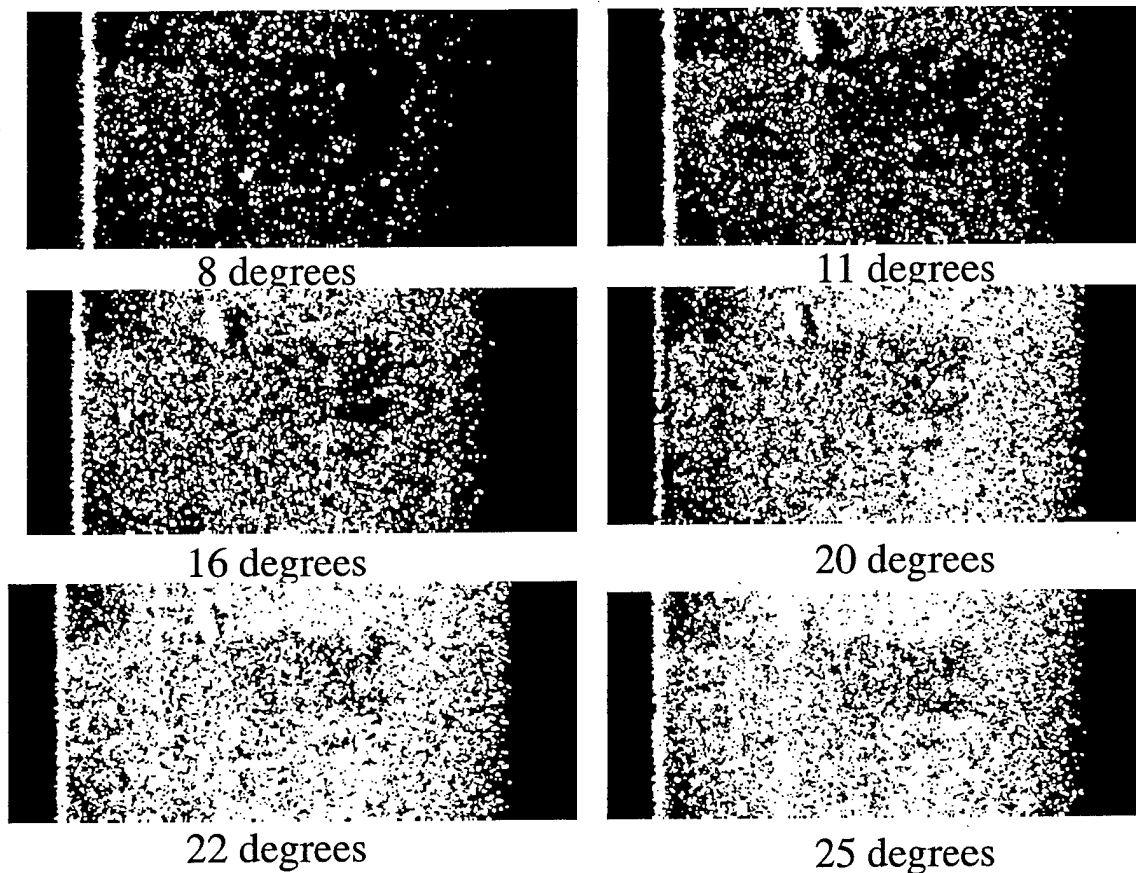
We employed a simple threshold filtering with this set of images as well. These processed images are shown below in the same sequence as above. The processed images make it very clear that as the incidence angle increases the dark areas shrink. As the angle of the illuminating light changes, it reflects off deeper areas of the surface features.

Figure 14. The result of the threshold technique described above on the images generated from specular reflections. The dark portion of the image, especially for the fretting area, decreases as the angle of incidence increases. The increasing incident angle causes deeper portions of the surface feature to be illuminated.

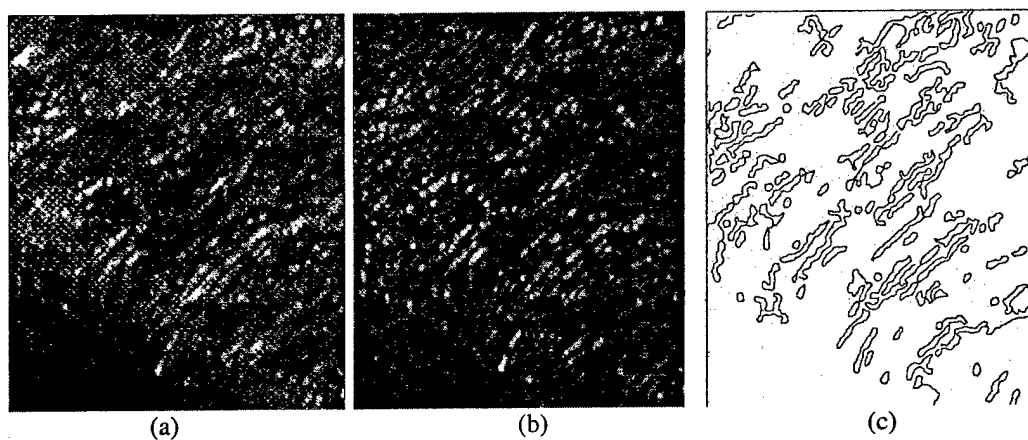
Figure 16: (a) Enlarged area of fretting damage; (b) image after morphological filtering; (c) boundary extraction result.

Once fretting damage regions have been detected, fine detail analysis is employed locally for fretting damage characterization. A boundary extraction algorithm is used for estimating the location and spatial extent of the damaged region and also providing geometrical detail of the region. The algorithm is implemented based on a vector image model and particle motion in a vector field. Figure 16 illustrates the result of boundary extraction: Figures 16-a shows the enlarged view of fretting damage area in Figure 15-a, Figure 16-b shows the results of morphological processing, and Figure 16-c shows the extracted boundaries. Figure 17 shows another example of the fretting damage image and the extracted outlines. Note that, in Figure 17, fretting damage is contained in the diagonal area of the image. The distinctive elongated shape of the ridges associated with fretting damage is clearly visible.

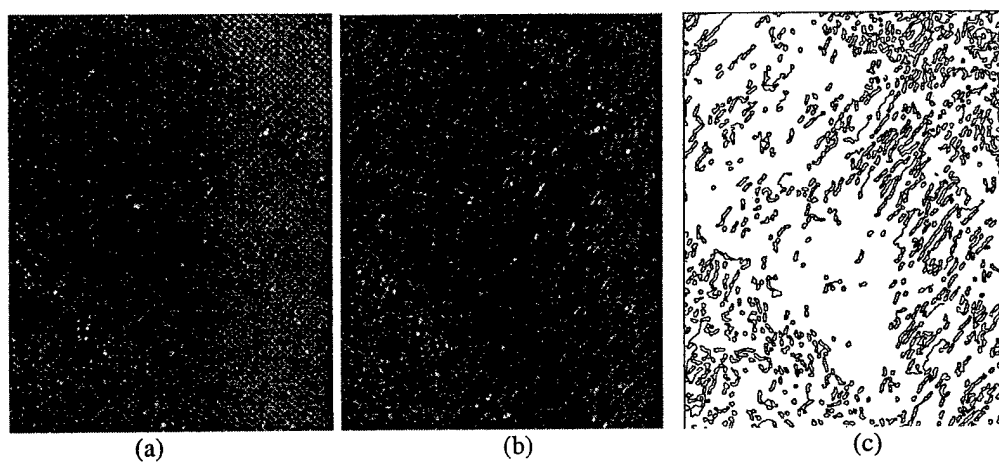
Figure 17: (a) Fretting damage image; (b) image after morphological filtering; (c) boundary extraction result.
